December 5, 2024

This report summarizes my visit to the Donovan Drive Holdings LLC property (Treetop Development Project) made on December 5, 2024. My credentials include my training and professional service as a Professional Forester and Arborist for the last 35 years. Many of the roles in this capacity involve evaluation of the condition of trees and tree parts to determine their state of life and health. Many times this evaluation is done forensically, following cutting of the tree or tree part.

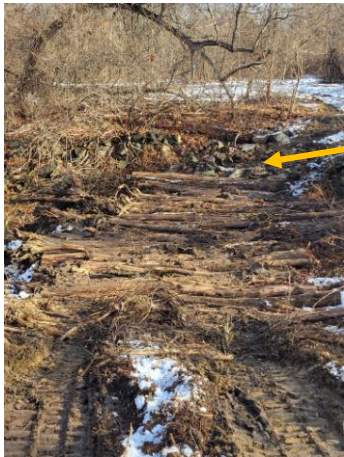
1. The small stream on the property has been crossed by the small excavator and skid steer forestry mower using corduroy logs placed in the stream parallel to the water flow. This is a totally- acceptable method to cross a stream this size. Since my last inspection, the crew did increase the amount of logs acting as corduroy. This will allow more space between equipment and the water flowing there. This area will need monitoring to help minimize silt and fines from getting into the stream. On this visit I observed that more log corduroy was needed on the south side of the stream, and communicated that to the crew foreman. I also observed that stream water exiting the corduroy crossing was free from any mud or fines. This was a positive indication of the effectiveness of this crossing method. Rain and warmer temperatures are forecasted for next week, so following my early-week inspection, we may have to enhance the crossing.

Enhanced
corduroy
crossing

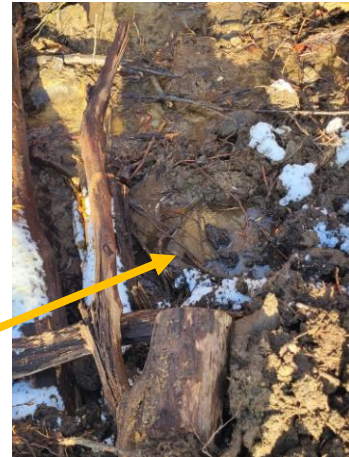
Stream
water
exiting
corduroy

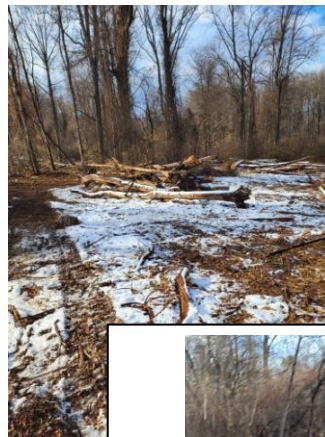
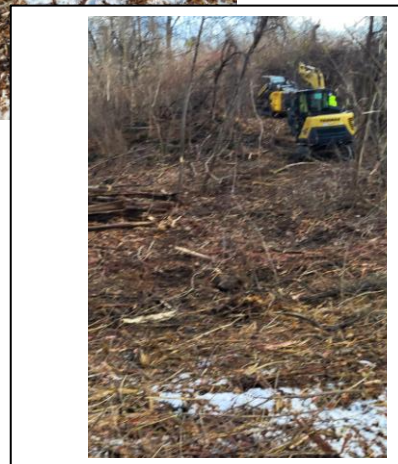
My inspection today of the work done so far indicated that no live trees had been cut, as no fresh-cut tree stumps were seen anywhere in the areas mowed. A small excavator appears to have been used to move downed logs around, and some of these downed logs appear to have been cut to shorted lengths to allow for them to be moved and stacked. All shrub stumps have been cut close to grade level, as well as fallen up-rooted tree stumps have been cut near the root flare of the trunk. No stumps appear to have been removed and stacked or buried.
