Above the Flood: Elevating Your Floodprone House

FEMA 347/ May 2000

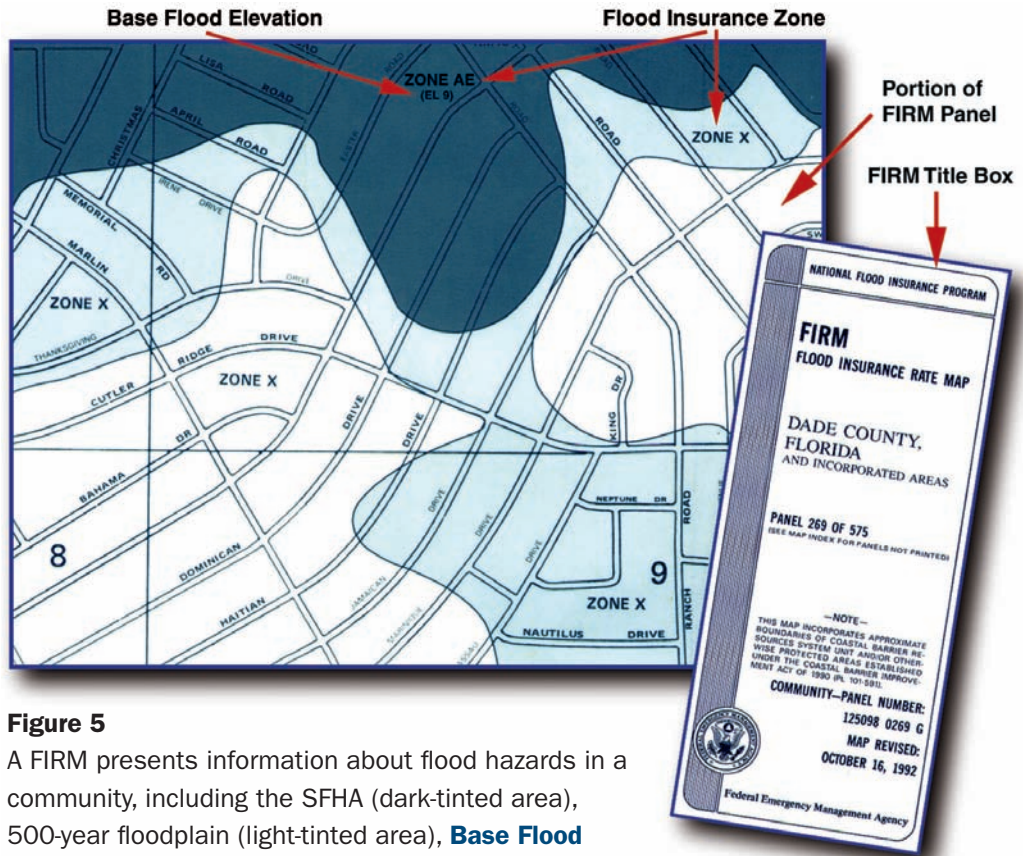
Figure 5
A FIRM presents information about flood hazards in a community, including the SFHA (dark-tinted area), 500-year floodplain (light-tinted area), **Base Flood Elevations**, (BFEs) (number in parentheses), and flood insurance zones (AE and X in this example).

Note that the SFHA in the example in Figure 5 is designated Zone AE. This zone is only one of several applied to SFHAs under the NFIP, including V, VE, V1-V30, A, AE, A1-A30, AO, and AH. These zones indicate differences in the types and severity of flood hazards in SFHAs. For the purposes of this publication, it is sufficient to focus on the basic differences between the two main types of SFHA zones—V zones and A zones. The distinction is important because regulatory requirements associated with V zones and A zones differ significantly. As explained later in this chapter, these requirements affect the types of building elevation techniques that may be used under the NFIP.

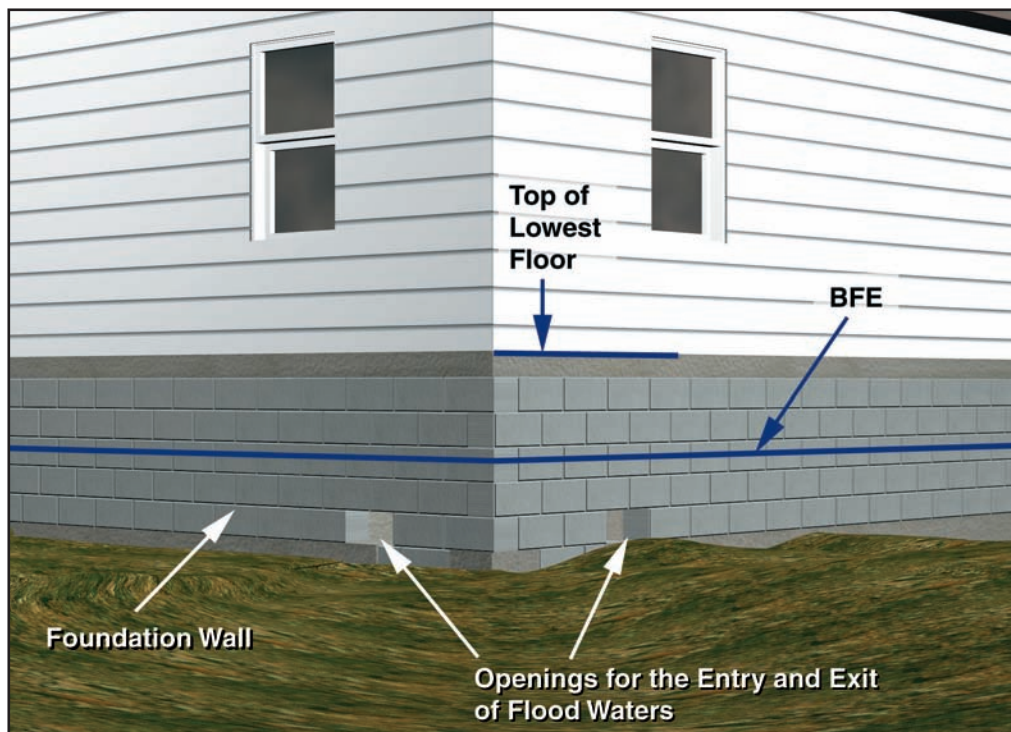
Figure 6

In a new, substantially improved, or substantially damaged building in an A zone, the elevation of the lowest floor must be at or above the BFE.

In A zones, where flood hazards are less severe, buildings may be elevated either on an open foundation or on continuous foundation walls below the BFE (Figure 6). Regardless of the type of foundation used, A-zone buildings must be elevated so that the **lowest floor** is at or above the BFE, as shown in Figure 6. If continuous walls are used below the BFE, they must be equipped with openings that allow flood waters to flow into and out of the area enclosed by the walls (Figure 6). Allowing the entry and exit of flood waters ensures that water pressures will be the same on both sides of the walls and reduces the likelihood that water pressure will cause the walls to fail.

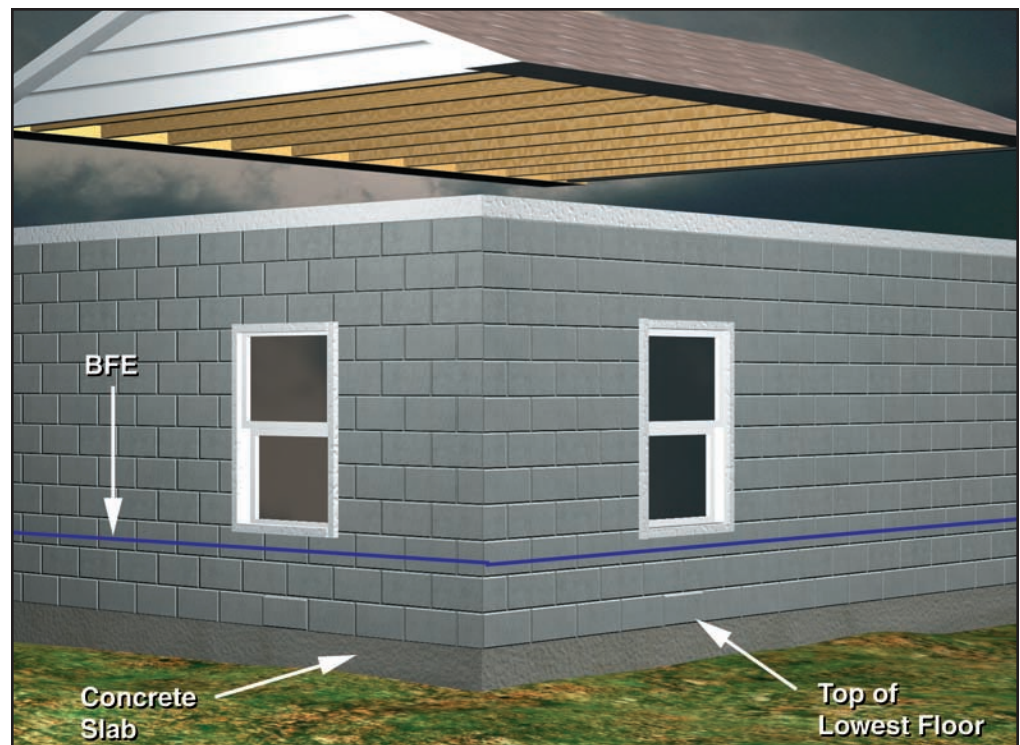
Figure 10
The first step in Technique 1 is removing the roof.

Technique 1 is appropriate for houses with concrete or masonry walls, but not for houses with other types of walls, such as those framed with wood studs, which would be more vulnerable to flood damage. This technique is usually appropriate when the depth of the base flood at the house is no more than 4 or 5 feet above grade. The elevation process begins with the temporary removal of the roof and roof framing, in a single piece if possible (Figure 10). This is commonly done with a crane. The roof is then stored on site so that it can be reinstalled later. The next step is to remove the windows and doors.

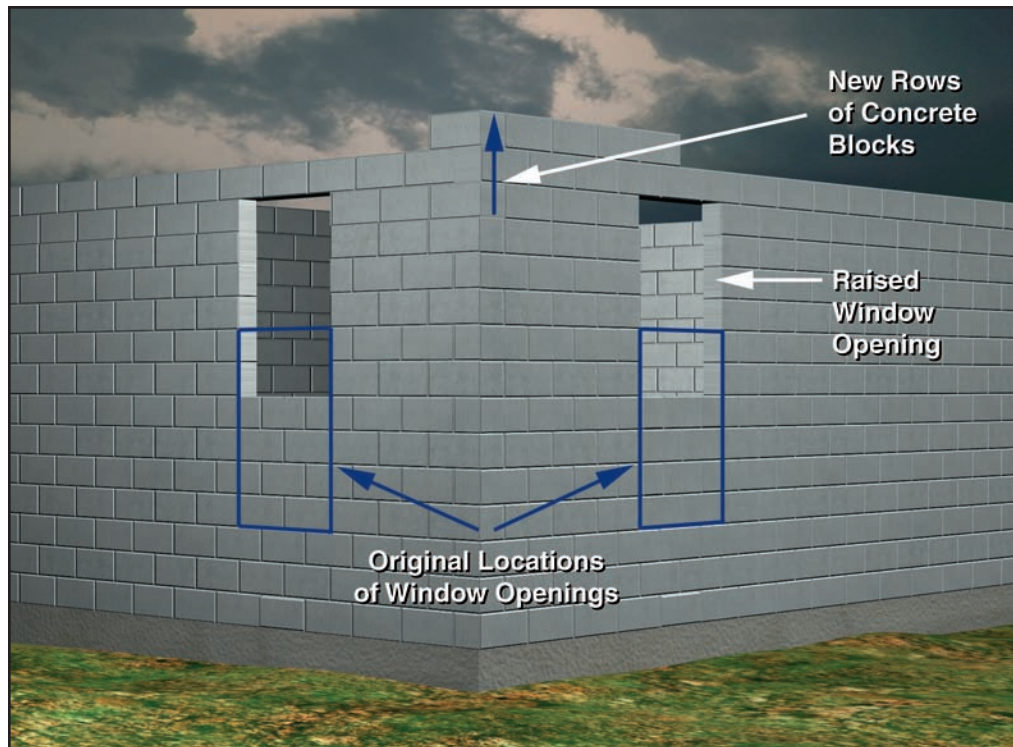
The tops of the walls and bottoms of the window openings are raised with concrete blocks.

After the roof, windows, and doors are removed, several courses of concrete block are added to the tops of the existing walls and to the bottoms of the window openings (Figure 11). A corresponding number of blocks are removed from the tops of the window openings so that the size of the windows will remain the same. In addition, although not shown in Figure 11, concrete bond beams are formed in place at the tops of the extended walls to provide structural reinforcement.

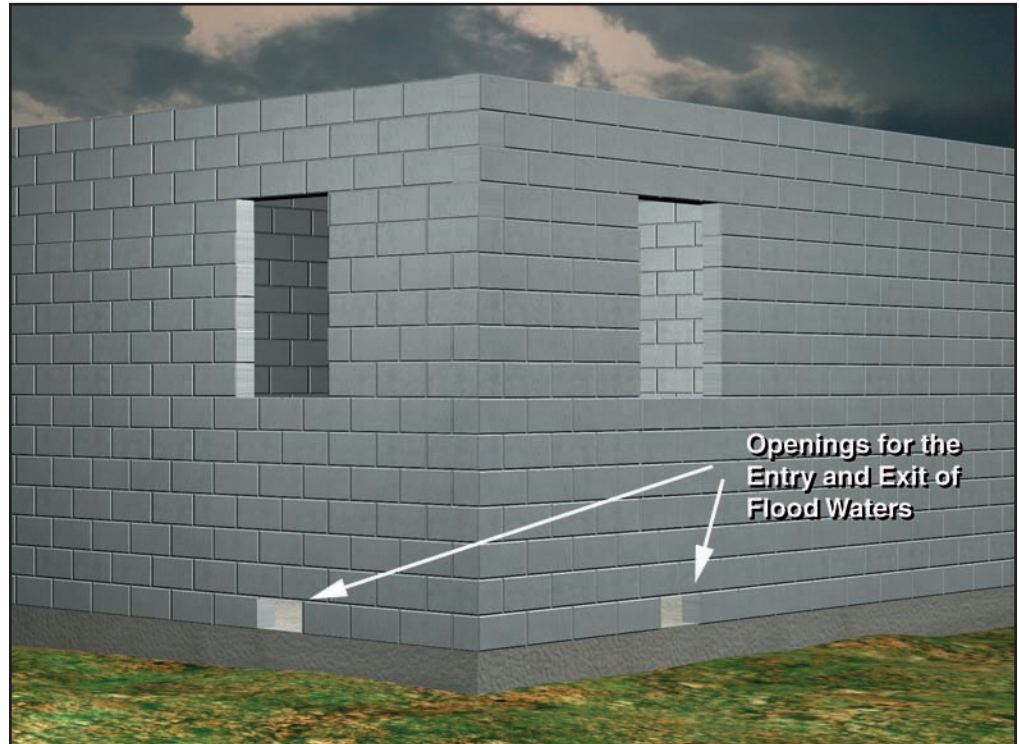
Figure 12
Openings are created in the walls near the ground.

Blocks are removed from the walls of the house at selected locations within 1 foot of the ground (Figure 12). The resulting openings will allow flood waters to flow into and out of the lower area of the house so that the water pressures on both sides of the walls will remain the same. The roof and windows are then replaced, and a new wood-frame floor is constructed above the flood level (Figure 13).

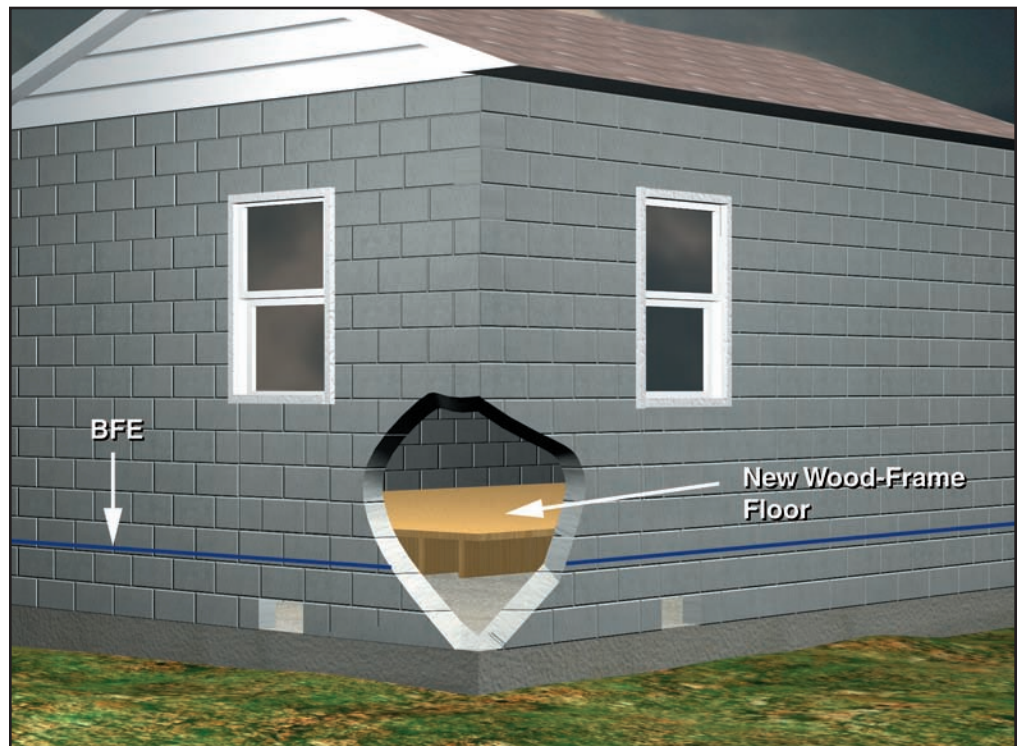
Figure 13
A new wood-frame lowest floor is constructed above the flood level, and the roof, windows, and doors are reinstalled.

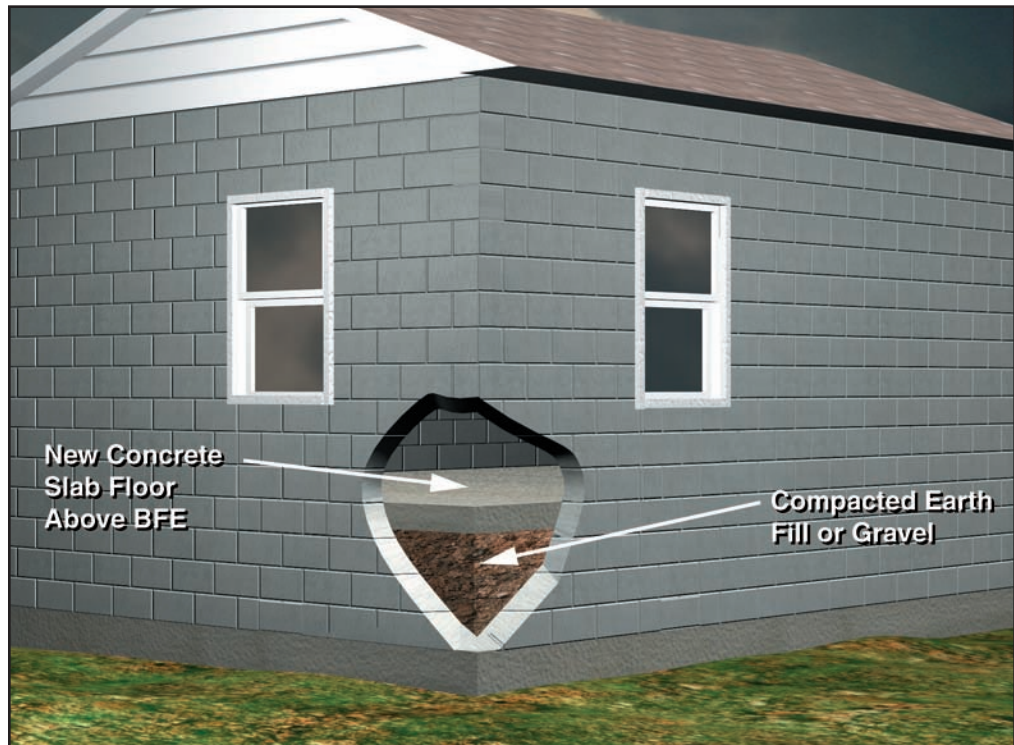
Figure 14
An alternative to building an elevated wood-frame floor is installing a new, elevated concrete slab floor on fill placed over the old slab.

A homeowner who chooses Technique 1 may decide to build a new concrete slab floor instead of a wood floor (Figure 14). When this option is chosen, compacted fill dirt or gravel is placed on top of the old slab and the new slab floor is poured on top. Because the area below the new floor is filled with dirt or gravel, wall openings are not required.

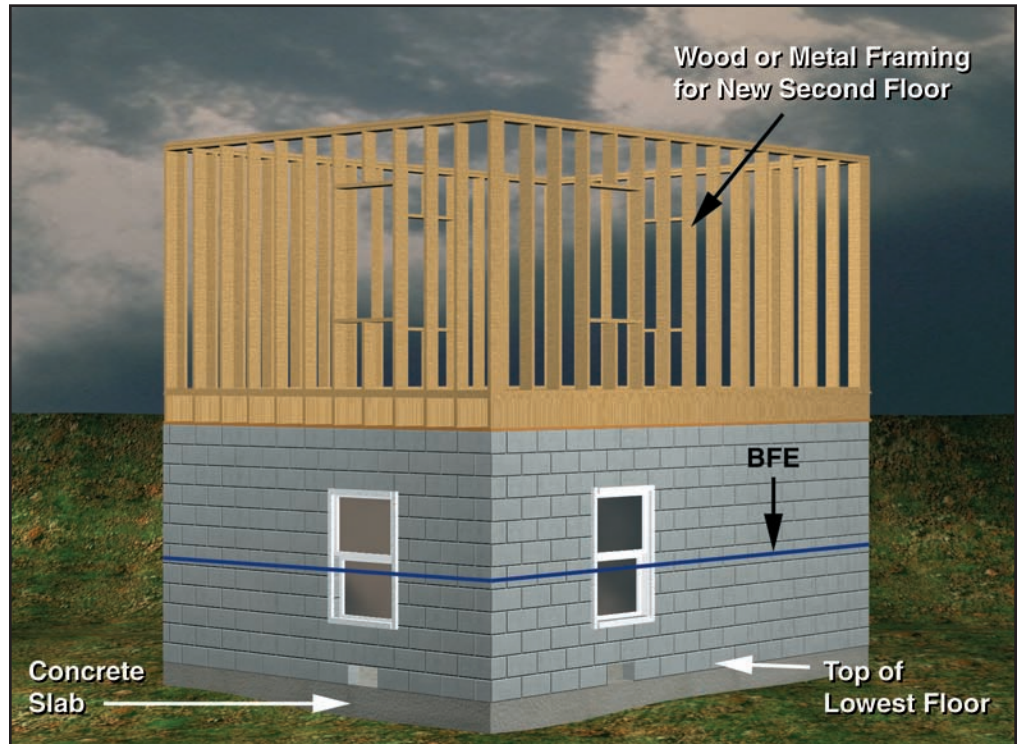
Figure 15
The new second-story floor and walls are built on top of the existing lower story.

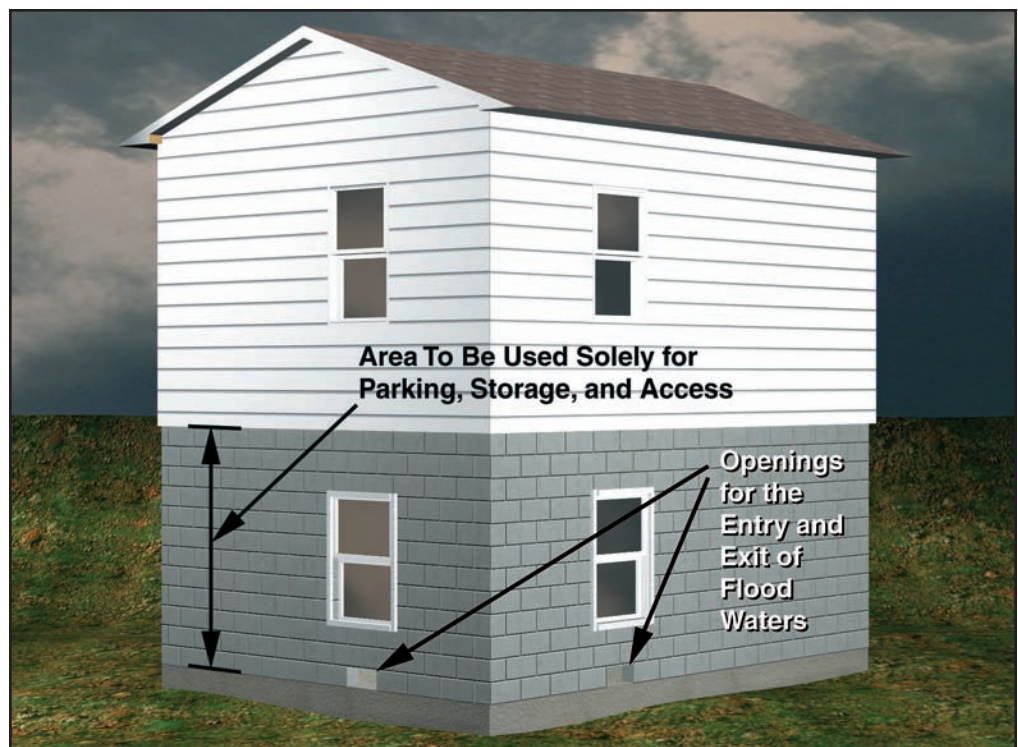
Figure 16
The new second-story walls are covered with siding or stucco.

Some homeowners prefer that the second story be constructed of masonry, but wood- or metal-framing is more common, primarily because it is lighter and less expensive. The roof is replaced, and blocks are removed from the walls to allow flood waters to enter and exit. Exterior sheathing is then added to the framed walls of the second story, the new windows are installed, and siding or stucco is applied to the sheathing (Figure 16).

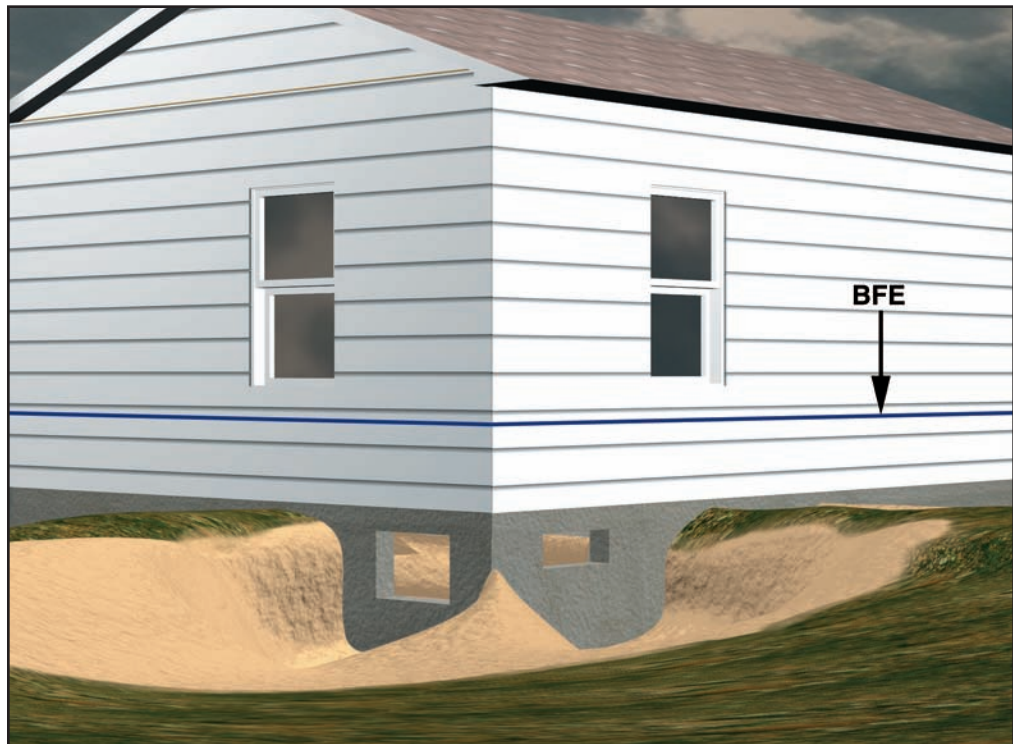
Figure 17
Trenches and tunnels under the slab provide access for the jacks and I-beams that will lift the house.

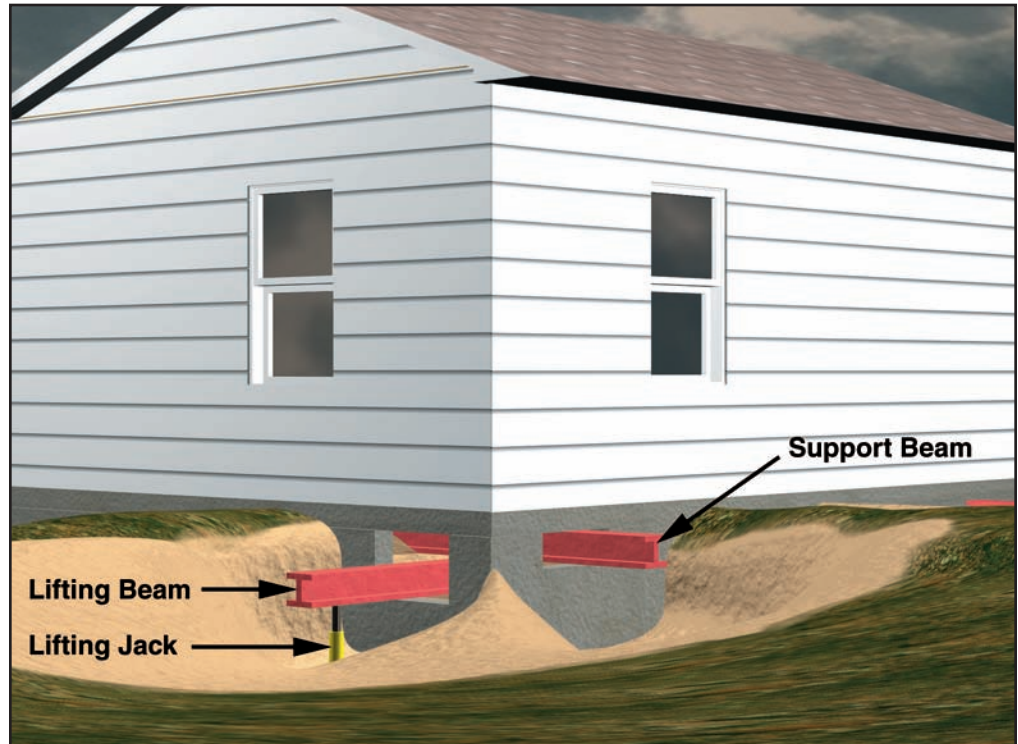
Figure 18
With I-beams and jacks in place, the house is ready to be lifted.

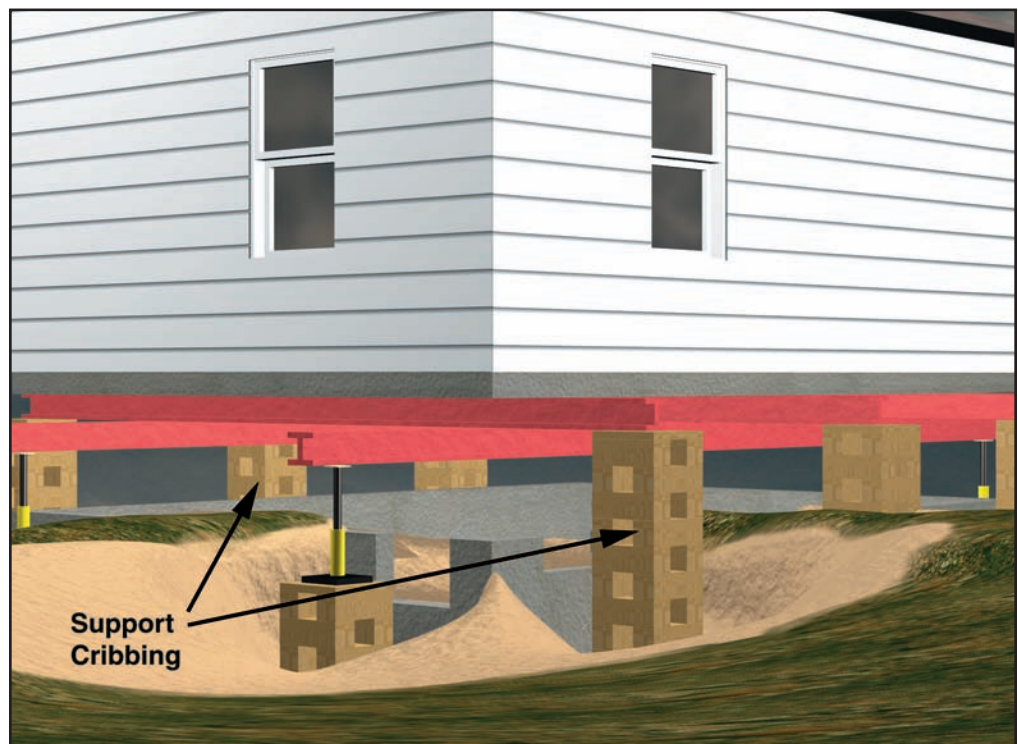
Figure 19
The house is temporarily supported on cribbing.

The house is then jacked up. When the jacks have extended as far as possible, the house must be supported temporarily while the jacks are raised. Both the house and the jacks are usually supported on “cribbing”—temporary piles of crisscrossed timbers (Figure 19). The jacks are then used to raise the house higher.

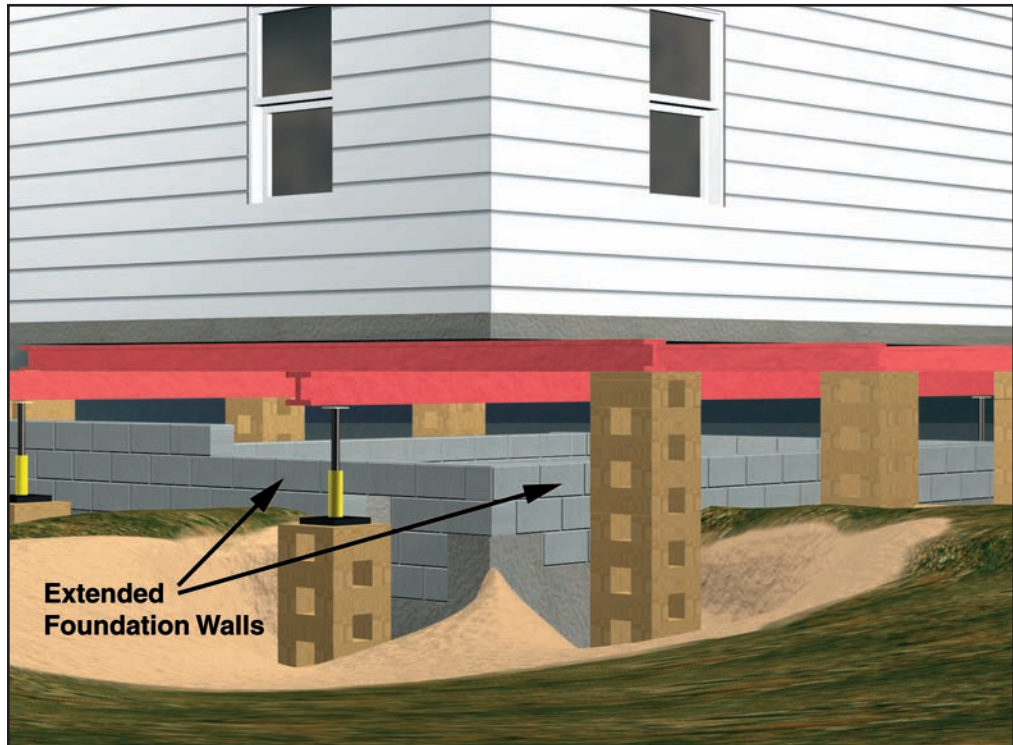
Figure 20
New, extended
foundation walls are
constructed with
concrete blocks.

This process is repeated until the house is raised to the desired height. The foundation walls are then extended upward with additional rows of concrete block (Figure 20). As in the previous techniques, openings are made in the walls within 1 foot of the ground so that flood waters will be able to flow into and out of the area below the elevated floor. The jacks and beams are removed, and the openings left around the beams are filled with blocks (Figure 21).

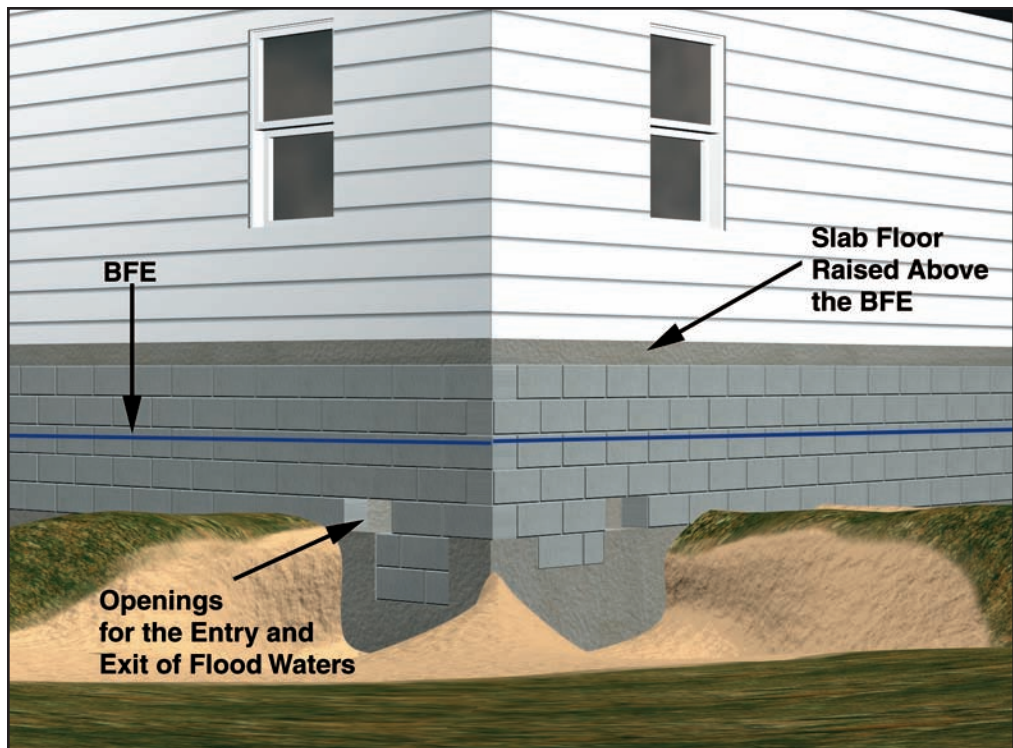
Figure 21
Elevated house and
slab on new, extended
foundation walls.

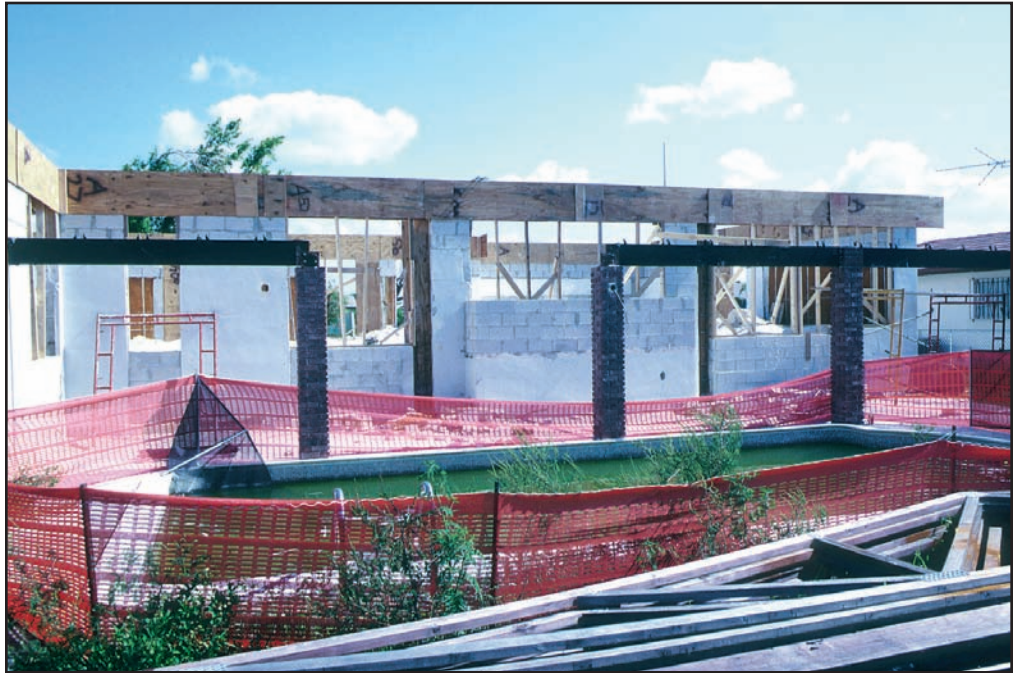
Figure 23
View from the back of the house. The walls have been extended upward with concrete blocks. The plywood visible at the tops of the walls is used to form cast-in-place concrete bond beams that will strengthen the extended walls. The roof trusses shown in the foreground were salvaged for reinstallation. The owner of this house decided to replace the original roof sheathing and shingles with new materials.

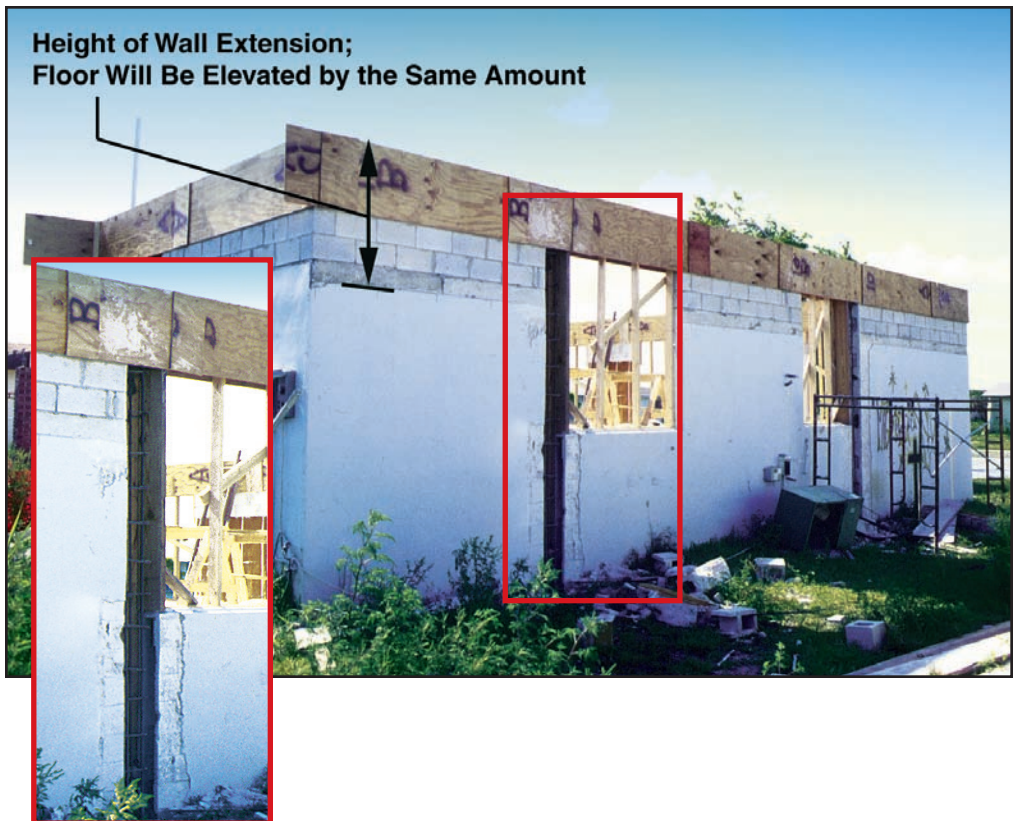
Figure 24
Another view of the extended walls. The vertical cuts in the walls next to the windows are for concrete tiedown columns that will be cast in place to further strengthen the extended walls against wind loads. The owner of this house was able to meet the elevation requirement by raising the floor only a few feet, as indicated by the amount that the walls have been extended.

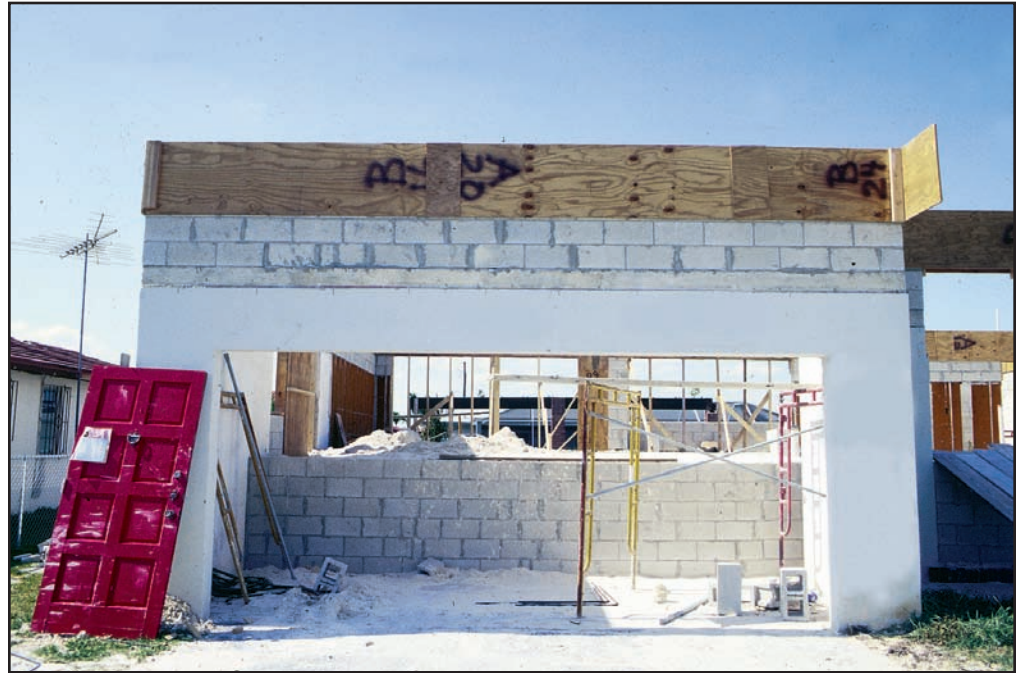
Figure 25

This view through the garage door reveals the different levels of the elevated slab floor, in the background, and the unelevated garage floor.

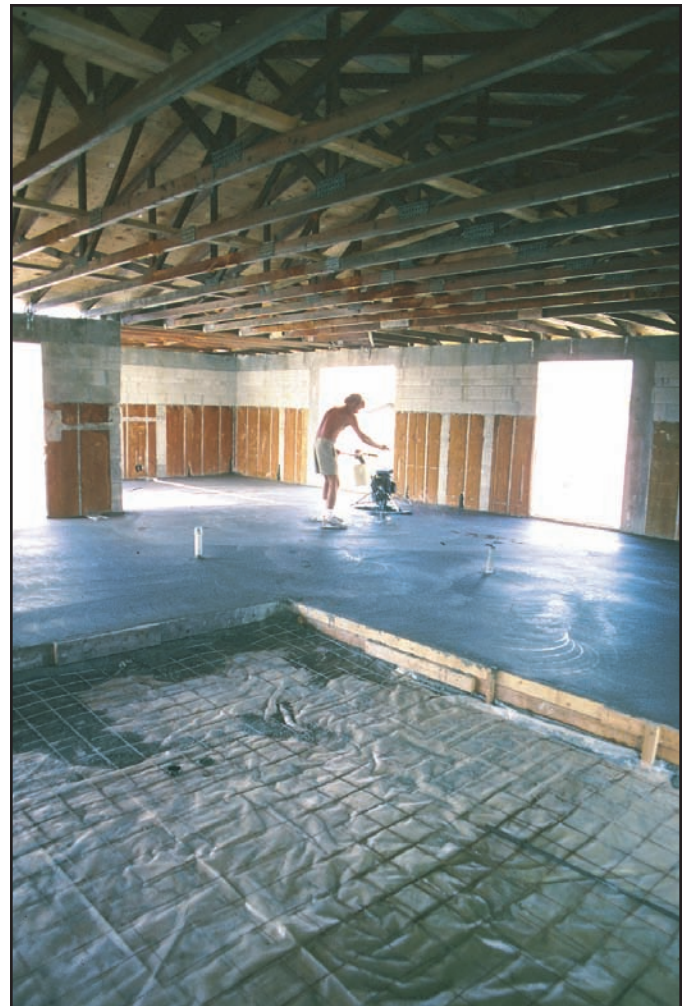
**Figure 26**

The roof has been rebuilt with the salvaged trusses, and most of the new concrete slab has been poured on top of the sand fill. The open area in the foreground, where plastic sheeting and wire reinforcement can be seen on top of the sand fill, is where the remaining part of the slab will be poured.

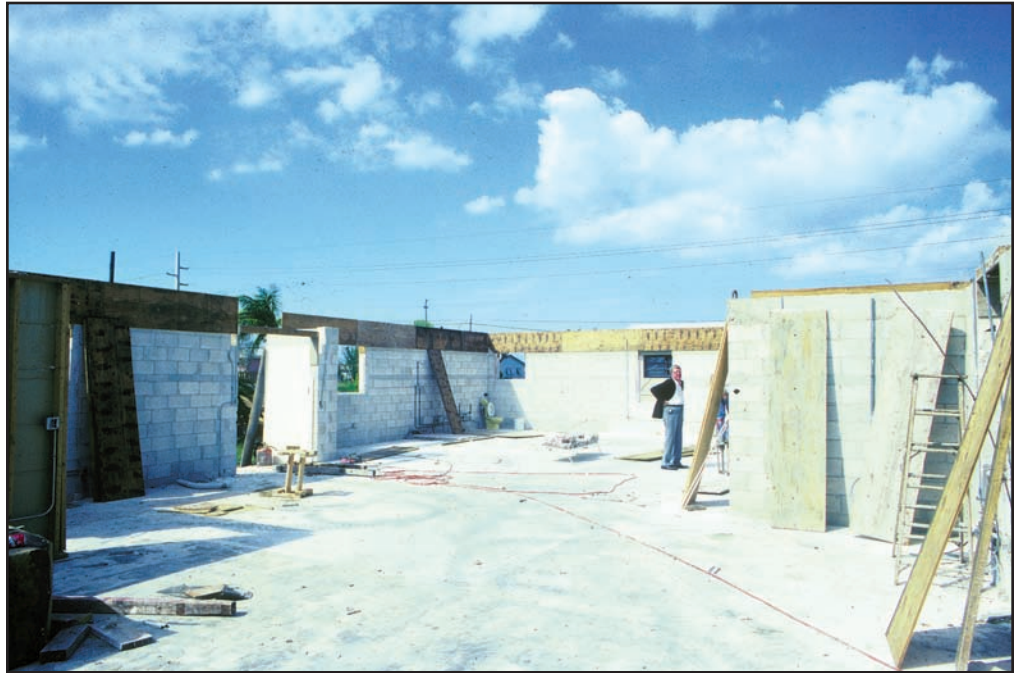
Figure 40

After the roof was removed and the storm-damaged interior gutted, the walls of the house were extended upward and a new bond beam added at the top.

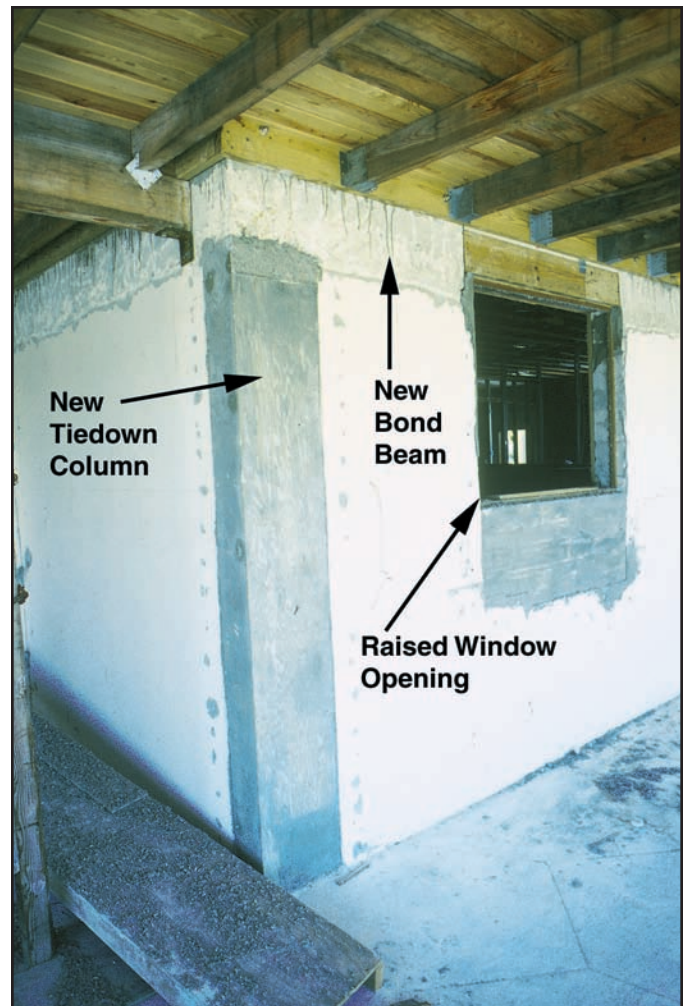
**Figure 41**

Note the new bond beam at the top of the extended wall, the new concrete tiedown column at the corner, and the raised window opening.

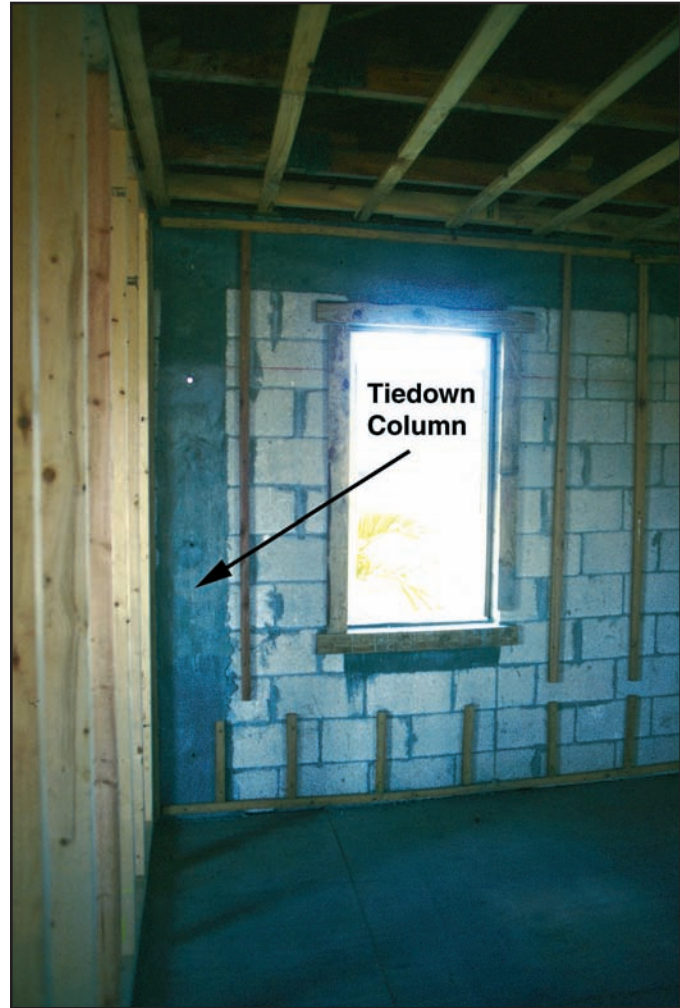
Figure 46
Concrete tiedown columns, such as the one to the left of the window in this photograph, were also used in this house.

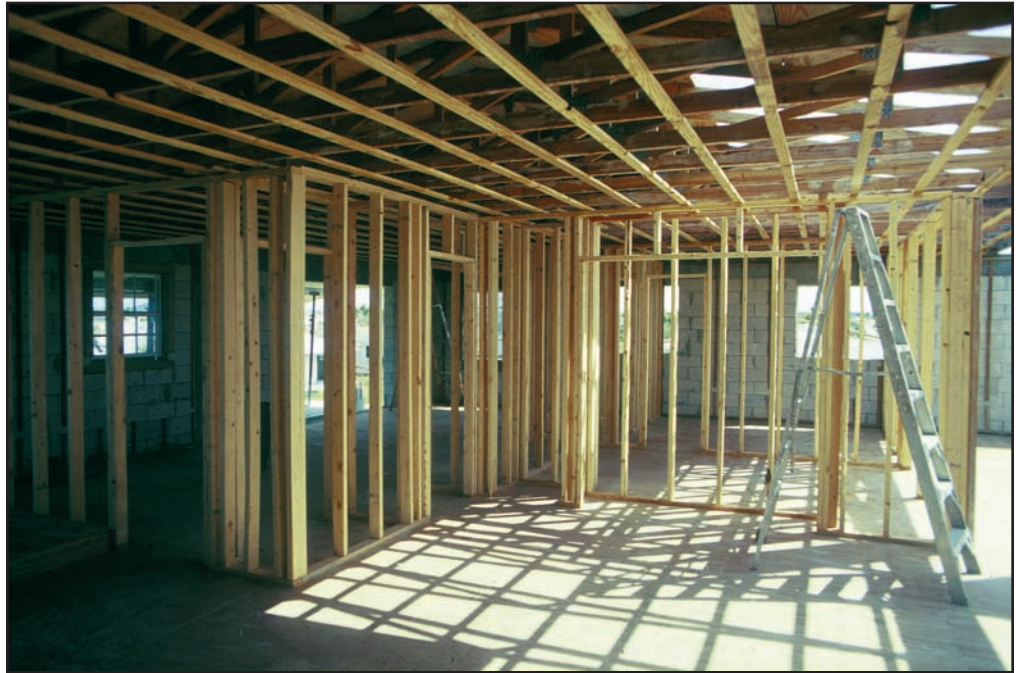
Figure 48
Wood 2 by 4 studs
were used to frame
the interior walls of
the second story.

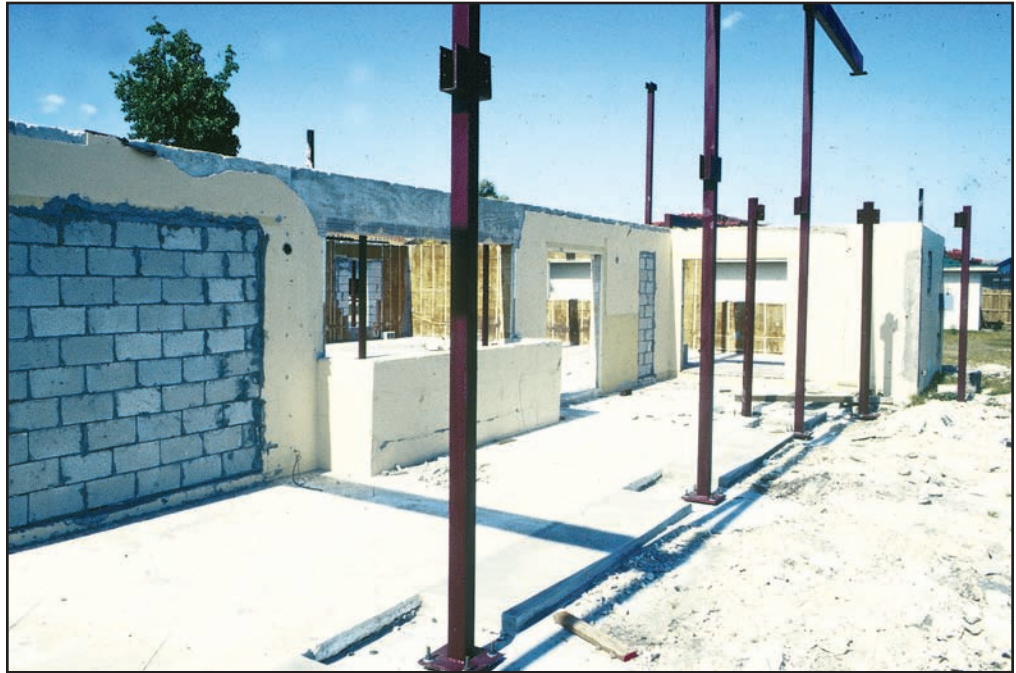
Figure 52

The existing first-story walls have been strengthened by the addition of concrete block. Metal columns and beams have been added to help support the new second story.

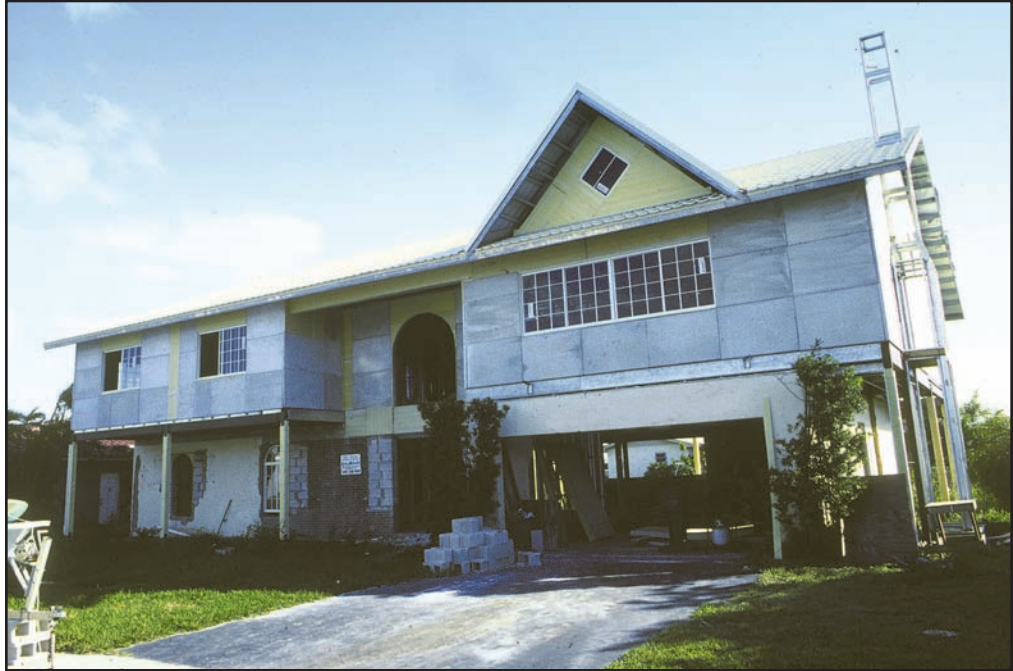
Figure 58

The new second story
nears completion.
The roof is made of
formed metal panels.

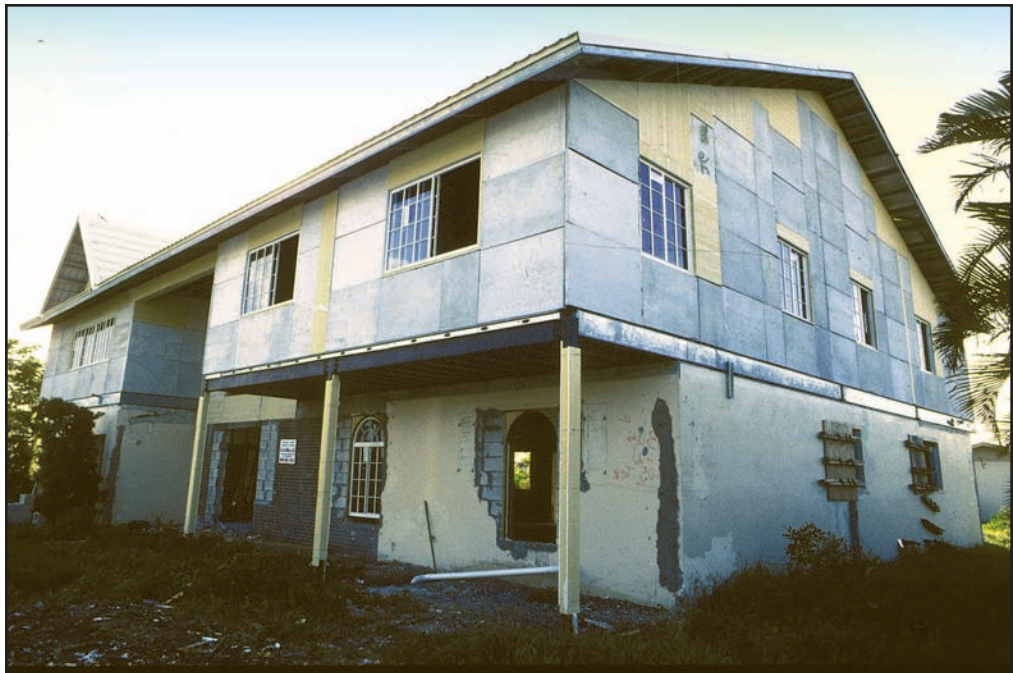
Figure 59

The exterior
walls consist of
prefabricated
concrete panels.
Innovative techniques
such as those
employed in this
project are helping
homeowners who
need practical and
economical methods
of repairing and
protecting their
houses.
